**Flood Control Project Maintenance
Levee Inspections**

Maintenance Issue Types Only, Levee Inspection Report By Mile - Spring 2019

Reclamation District No. 0785 Driver

Waterway	Bank	Unit Miles	Inspection Start/End	Inspector
Unit No. 01 Sacramento River	Right	2.26	03/07/2019 03/07/2019	Zach Jojola

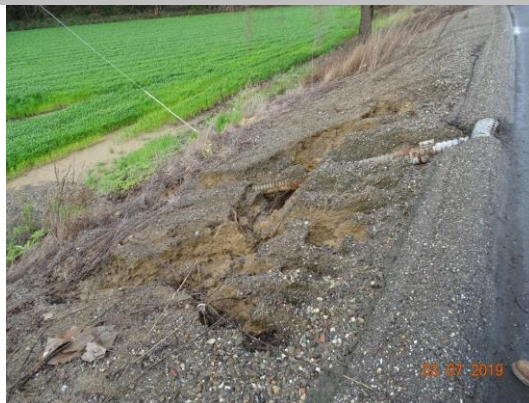
Photo 1 of 6 : SP_2019_RD0785_185_9_20190311_00040.jpg

LM Start	0.11	Rating **	U	Issue No.	9
LM End	0.11	Issue Type +	Ma	Location *	LS
Category	Earthen Levee			GPS Latitude/Longitude	
				Start	End
Item	Erosion / Bank Caving			38.660211 °	38.660211 °
				-121.611748 °	-121.611748 °
DWR ID	DWR_RD0785_01_f_2017_9				
Comment Code					
E2 : Schedule repair of erosion site prior to the next inspection.					
Inspector Comment					
Runoff erosion on landside slope that has gotten worse.

View of erosion on the landside slope. Spring 2019.

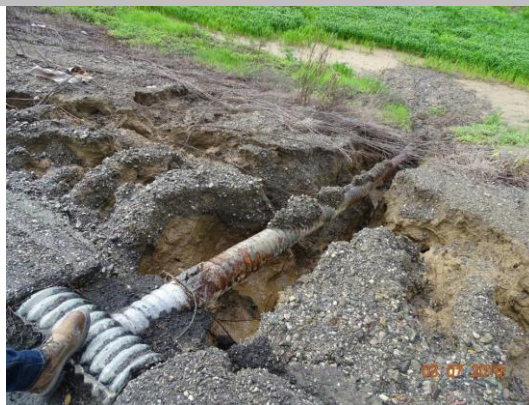
Photo 2 of 6 : SP_2019_RD0785_185_9_20190311_00041.jpg

View of erosion on the landside slope. Spring 2019.

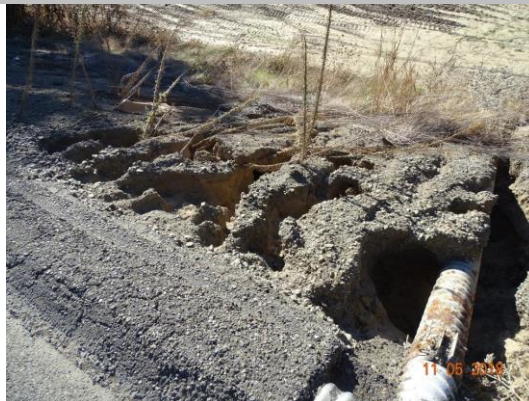
Photo 3 of 6 : SP_2019_RD0785_185_9_20190304_00003.jpg

View of erosion on the landside slope. Fall 2018.

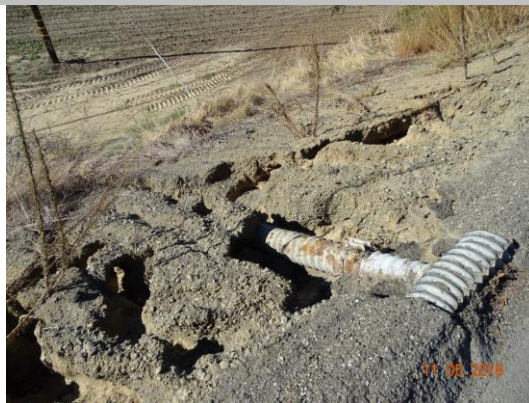
Photo 4 of 6 : SP_2019_RD0785_185_9_20190304_00004.jpg

Additional view of erosion on the landside slope. Fall 2018.

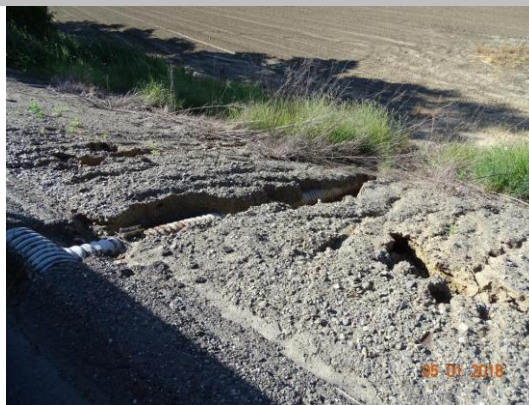
Photo 5 of 6 : SP_2019_RD0785_185_9_20190304_00006.jpg

View of runoff on the landside slope. Spring 2018.

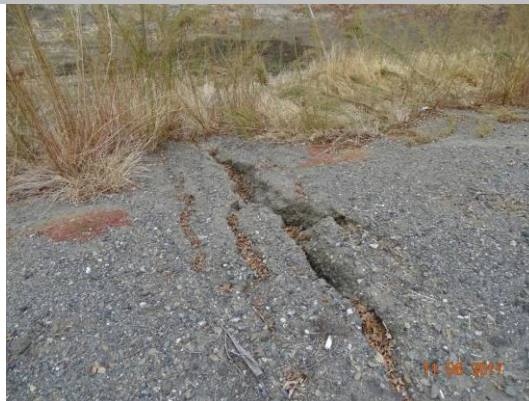
Photo 6 of 6 : SP_2019_RD0785_185_9_20190304_00007.jpg

View of runoff erosion on the landside slope. Fall 2017.

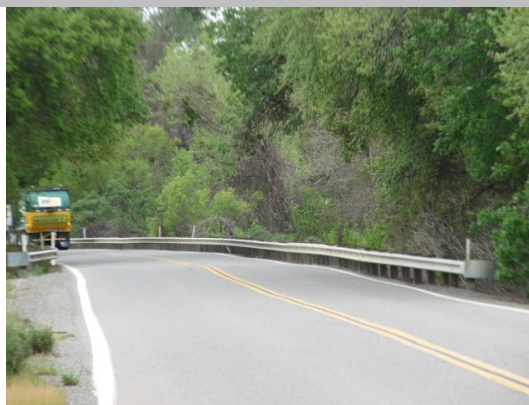
Photo 2 of 2 : SP_2019_RD0785_185_16_20190304_00013.jpg

Brush and other vegetation partially blocks visibility. Spring 2014

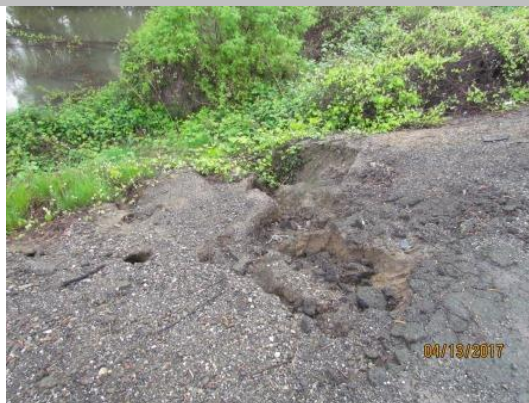
Photo 1 of 1 : SP_2019_RD0785_185_24_20190304_00015.jpg

LM Start	0.24	Rating **	M	Issue No.	24
LM End	0.24	Issue Type +	Ma	Location *	WS
Category	Earthen Levee			GPS Latitude/Longitude	
				Start	End
Item	Erosion / Bank Caving			38.658998 °	38.658998 °
				-121.610081 °	-121.610081 °
DWR ID	DWR_RD0785_01_s_2017_24				
Comment Code					
E2 : Schedule repair of erosion site prior to the next inspection.					
Inspector Comment					
Runoff erosion on waterside slope.

Runoff erosion on waterside levee slope. Spring 2017.

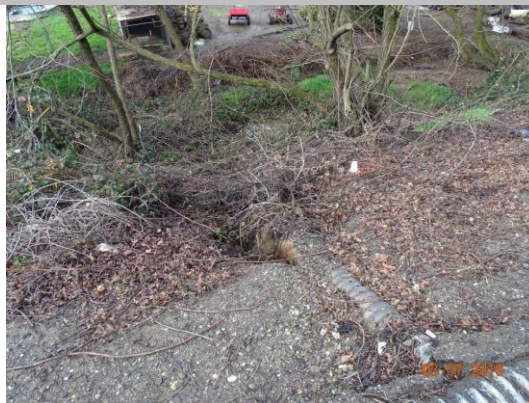
Photo 1 of 1 : SP_2019_RD0785_185_22_20190311_00042.jpg

LM Start	0.64	Rating **	M	Issue No.	22
LM End	0.64	Issue Type +	Ma	Location *	LS
Category	Earthen Levee			GPS Latitude/Longitude	
				Start	End
Item	Erosion / Bank Caving			38.654294 °	38.654294 °
				-121.605949 °	-121.605949 °
DWR ID	DWR_RD0785_01_s_2019_22				
Comment Code					
E2 : Schedule repair of erosion site prior to the next inspection.					
Inspector Comment					
Erosion around drainage pipe.

View of erosion on the landside slope. Spring 2019.

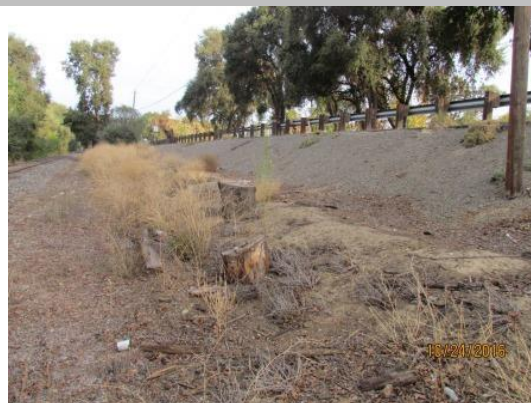
Photo 1 of 1 : SP_2019_RD0785_185_28_20190304_00016.jpg

LM Start	0.99	Rating **	N	Issue No.	28
LM End	0.99	Issue Type +	Ma	Location *	LS
Category	Earthen Levee			GPS Latitude/Longitude	
				Start	End
Item	Trim / Thin Trees			38.650055 °	38.650055 °
				-121.602752 °	-121.602752 °
DWR ID	DWR_RD0785_01_f_2016_28				
Comment Code					
T5 : Tree stumps.					
Inspector Comment

Two tree stumps near levee toe on landside. Fall 2016.

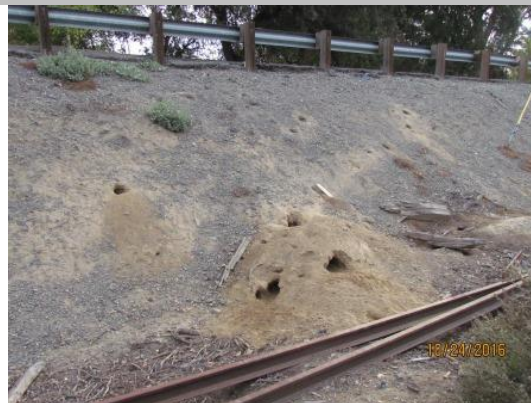
Photo 1 of 2 : SP_2019_RD0785_185_29_20190304_00017.jpg

LM Start	1.02	Rating **	M	Issue No.	29
LM End	1.02	Issue Type +	Ma	Location *	LS
Category	Earthen Levee			GPS Latitude/Longitude	
				Start	End
Item	Animal Control			38.649798 °	38.649798 °
				-121.602373 °	-121.602373 °
DWR ID	DWR_RD0785_01_f_2016_29				
Comment Code					
A3 : No rodents visible, but rodent burrows visible; need to backfill and compact or grout burrows.					
Inspector Comment					
Rodent holes on the landside slope.

View of rodent holes on LS slope. Fall 2016.

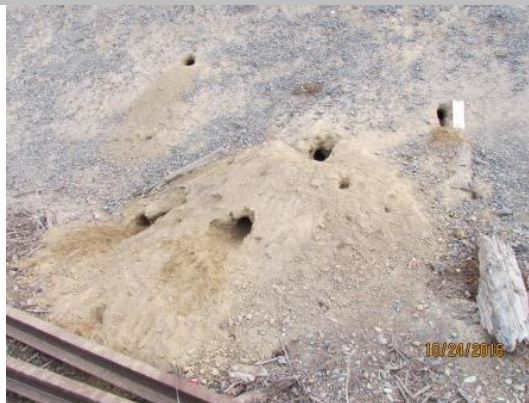
Photo 2 of 2 : SP_2019_RD0785_185_29_20190304_00018.jpg

Another view of rodent holes. Fall 2016.

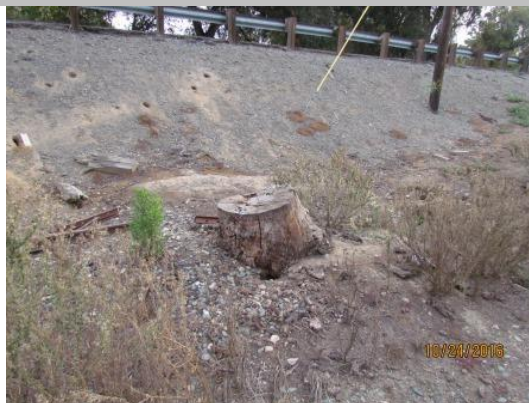
Photo 1 of 1 : SP_2019_RD0785_185_30_20190304_00019.jpg

LM Start	1.02	Rating **	N	Issue No.	30
LM End	1.02	Issue Type +	Ma	Location *	LS
Category	Earthen Levee			GPS Latitude/Longitude	
				Start	End
Item	Trim / Thin Trees			38.649775 °	38.649775 °
				-121.602363 °	-121.602363 °
DWR ID	DWR_RD0785_01_f_2016_30				
Comment Code					
T5 : Tree stumps.					
Inspector Comment					
Tree stump near levee toe

View of a stump near levee toe on landside. Fall 2016.

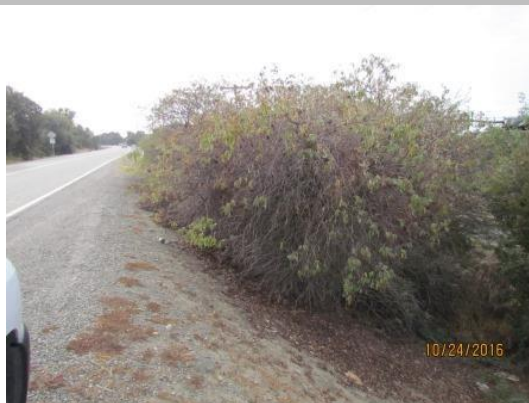
Photo 1 of 1 : SP_2019_RD0785_185_6_20190304_00002.jpg

LM Start	1.30	Rating **	A/W	Issue No.	6
LM End	1.30	Issue Type +	Ma	Location *	LS
Category	Earthen Levee			GPS Latitude/Longitude	
				Start	End
Item	Vegetation			38.646712 °	38.646712 °
				-121.599095 °	-121.599095 °
DWR ID	DWR_RD0785_01_s_2012_6				
Comment Code					
V4 : Elderberries are blocking visibility and flood fight capability.					
Inspector Comment

View of elderberry trees on LS slope. Fall 2016.

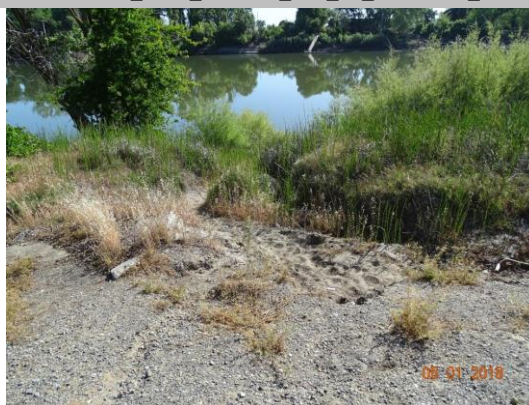
Photo 1 of 4 : SP_2019_RD0785_185_13_20190304_00008.jpg

LM Start	1.31	Rating **	M	Issue No.	13
LM End	1.31	Issue Type +	Ma	Location *	WS
Category	Earthen Levee			GPS Latitude/Longitude	
				Start	End
Item	Slope Stability			38.646652 °	38.646652 °
				-121.598907 °	-121.598907 °
DWR ID	DWR_RD0785_01_s_2013_13				
Comment Code					
S2 : Repair the levee slope damaged by foot traffic and prevent access where possible.					
Inspector Comment					
Footpath on the waterside slope.

View of slope stability on the waterside slope. Spring 2018.

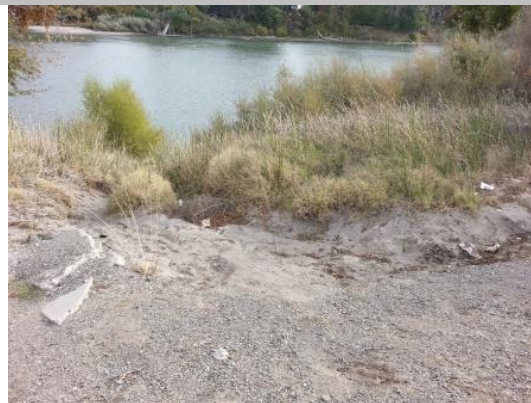
Photo 3 of 4 : SP_2019_RD0785_185_13_20190304_00010.jpg

LM Start	1.31	Rating **	M	Issue No.	13 (cont)	
LM End	1.31	Issue Type +	Ma	Location *	WS	
Category	Earthen Levee			GPS Latitude/Longitude		
				Start		End
Item	Slope Stability			38.646652 °		38.646652 °
				-121.598907 °		-121.598907 °
DWR ID	DWR_RD0785_01_s_2013_13					
Comment Code						
S2 : Repair the levee slope damaged by foot traffic and prevent access where possible.						
Inspector Comment						
Footpath on the waterside slope.

View of the slope stability site. Fall 2016.

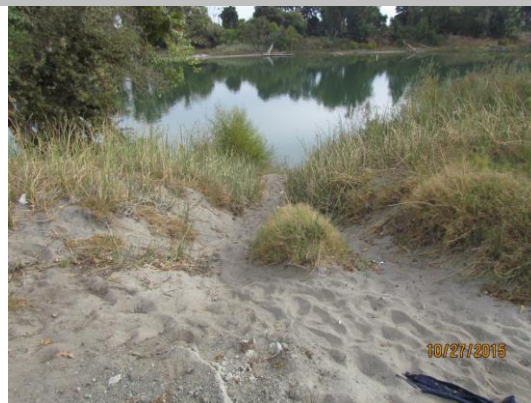
Photo 4 of 4 : SP_2019_RD0785_185_13_20190304_00011.jpg

View of the slope stability on the waterward side of the levee. Fall 2015.

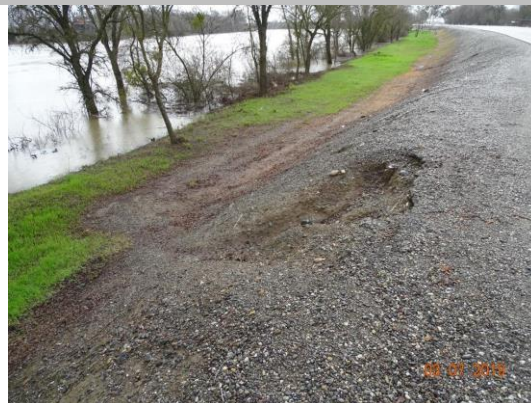
Photo 1 of 1 : SP_2019_RD0785_185_17_20190311_00039.jpg

LM Start	1.41	Rating **	M	Issue No.	17
LM End	1.41	Issue Type +	Ma	Location *	WS
Category	Earthen Levee			GPS Latitude/Longitude	
				Start	End
Item	Erosion / Bank Caving			38.645424 °	38.645424 °
				-121.597716 °	-121.597716 °
DWR ID	DWR_RD0785_01_s_2019_17				
Comment Code					
E2 : Schedule repair of erosion site prior to the next inspection.					
Inspector Comment					
Runoff erosion on the waterside slope.

View of runoff erosion on the waterside slope. Spring 2019.

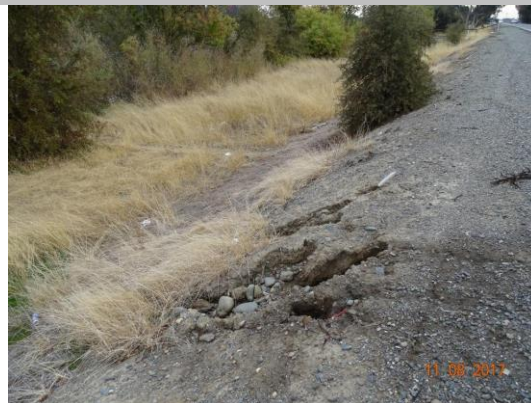
Photo 1 of 1 : SP_2019_RD0785_185_55_20190304_00024.jpg

LM Start	1.51	Rating **	M	Issue No.	55
LM End	1.51	Issue Type +	Ma	Location *	WS
Category	Earthen Levee			GPS Latitude/Longitude	
				Start	End
Item	Erosion / Bank Caving			38.644349 °	38.644349 °
				-121.596506 °	-121.596506 °
DWR ID	DWR_RD0785_01_f_2017_55				
Comment Code					
E2 : Schedule repair of erosion site prior to the next inspection.					
Inspector Comment					
Runoff on waterside slope.

View of the runoff erosion on the waterside slope. Fall 2017.

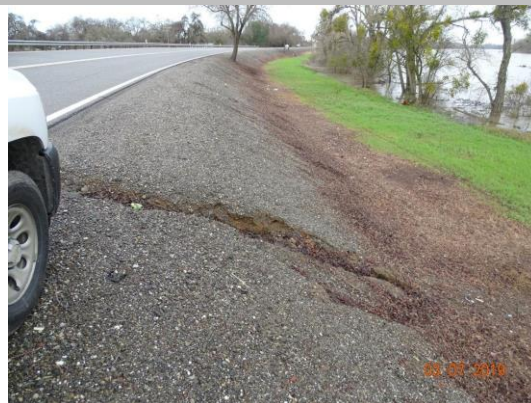
Photo 1 of 1 : SP_2019_RD0785_185_15_20190311_00038.jpg

LM Start	1.78	Rating **	M	Issue No.	15
LM End	1.78	Issue Type +	Ma	Location *	WS
Category	Earthen Levee			GPS Latitude/Longitude	
				Start	End
Item	Erosion / Bank Caving			38.642042 °	38.642042 °
				-121.592536 °	-121.592536 °
DWR ID	DWR_RD0785_01_s_2019_15				
Comment Code					
E2 : Schedule repair of erosion site prior to the next inspection.					
Inspector Comment					
Rills on the waterside slope.

View of rill on the waterside slope. Spring 2019.

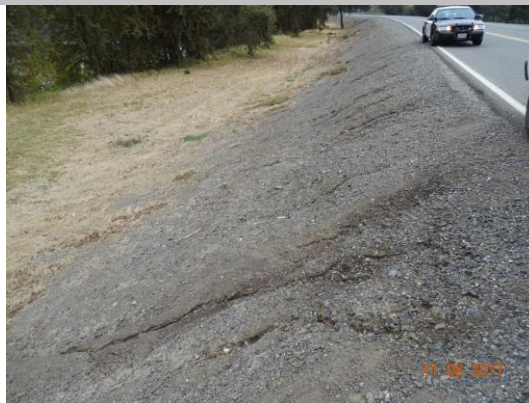
Photo 1 of 1 : SP_2019_RD0785_185_19_20190304_00014.jpg

LM Start	2.23	Rating **	A/W	Issue No.	19
LM End	2.23	Issue Type +	Ma	Location *	WS
Category	Earthen Levee			GPS Latitude/Longitude	
				Start	End
Item	Erosion / Bank Caving			38.642908 °	38.642908 °
				-121.584647 °	-121.584647 °
DWR ID	DWR_RD0785_01_s_2018_19				
Comment Code					
E1 : Note and monitor erosion site.					
Inspector Comment					
Runoff erosion on waterside slope. Recommend monitoring.

View of runoff erosion on the waterside slope. Fall 2017.

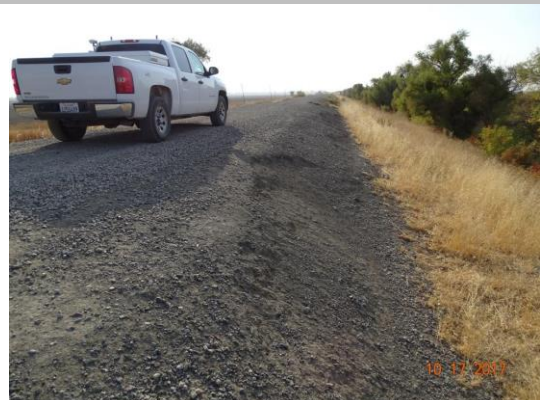
Photo 1 of 1 : SP_2019_RD0785_186_7_20190304_00002.jpg

LM Start	1.14	Rating **	A/W	Issue No.	7
LM End	1.14	Issue Type +	Ma	Location *	WS
Category	Earthen Levee			GPS Latitude/Longitude	
				Start	End
Item	Slope Stability			38.626440 °	38.626440 °
				-121.611164 °	-121.611164 °
DWR ID	DWR_RD0785_02_f_2017_7				
Comment Code					
S1 : Repair slope instability.					
Inspector Comment					
Minor sloughing on waterside hinge point. Recommend monitoring.

View of sloughing section on waterside hinge point. Fall 2017.

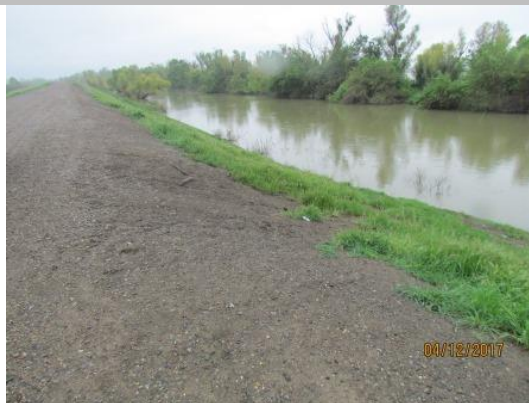
Photo 1 of 1 : SP_2019_RD0785_186_24_20190304_00004.jpg

LM Start	1.52	Rating **	M	Issue No.	24
LM End	1.52	Issue Type +	Ma	Location *	WS
Category	Earthen Levee			GPS Latitude/Longitude	
				Start	End
Item	Slope Stability			38.621694 °	38.621694 °
				-121.607610 °	-121.607610 °
DWR ID	DWR_RD0785_02_s_2017_24				
Comment Code					
S2 : Repair the levee slope damaged by foot traffic and prevent access where possible.					
Inspector Comment					
Footpath for environmental access site. There is a noticeable dip on the waterside slope.

View of slope stability on waterside levee slope. Spring 2017.

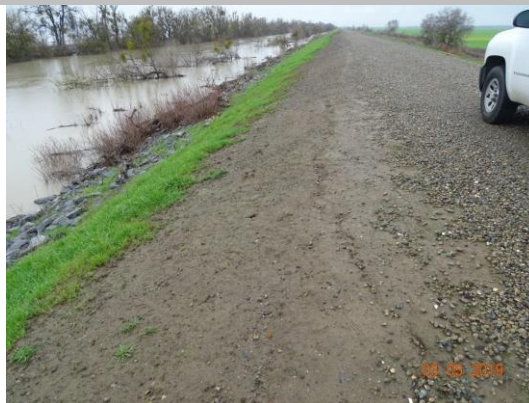
Photo 1 of 2 : SP_2019_RD0785_186_5_20190311_00008.jpg

LM Start	3.25	Rating **	A/W	Issue No.	5
LM End	3.25	Issue Type +	Ma	Location *	WS
Category	Earthen Levee			GPS Latitude/Longitude	
				Start	End
Item	Cracking			38.600241 °	38.600241 °
				-121.590948 °	-121.590948 °
DWR ID	DWR_RD0785_02_f_2018_5				
Comment Code					
CR1 : Monitor and have inspected by geotechnical engineer.					
Inspector Comment					
Cracking on the waterside shoulder. Approximately 50' long. Recommend monitoring.

View of crack on the waterside shoulder. Spring 2019.
